**PHASE I
ENVIRONMENTAL SITE ASSESSMENT**

**East Kapolei Brownfield Sites
Kapolei, O'ahu, Hawai'i 96707
TMK (1) 9-1-17:71 (portion)**

Environet Project No.: 408-042

January 22, 2009

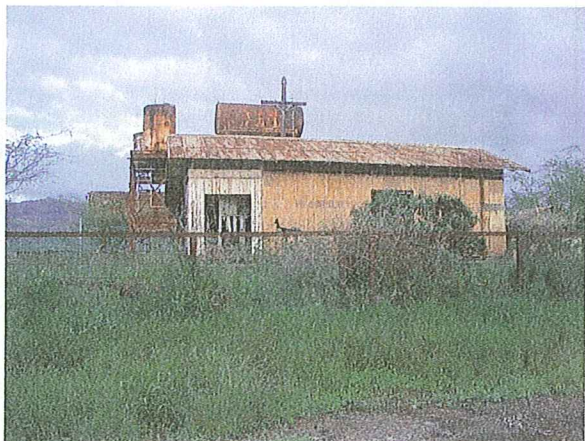
Photo 1: Former Oahu Sugar Company Pesticide Mixing and Loading Area.

O'ahu Sugar Company, a previous occupant, constructed the pesticide mixing and loading facility which was used until 1994 (Photo 1). The former mixing facility is currently fenced off and listed as a Brownfields site; access to this area was not obtained. Within the fenced area there were drums with a capacity of 55-gallons or less, a rusted corrugated steel structure, and four rusted tanks of various volumes. A derelict tanker truck is also stationed outside of the fenced area (Photo 2).

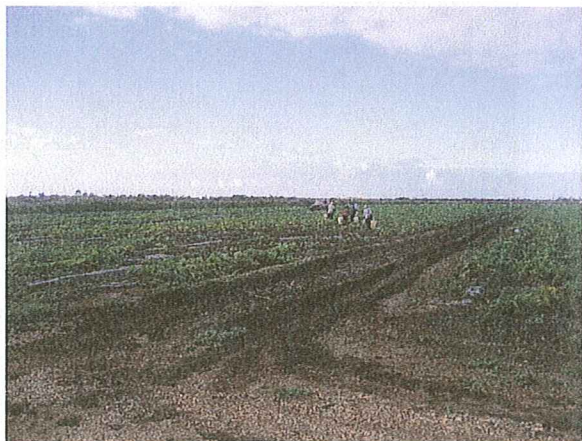
Photo 3: Small plots within Site are currently used for agricultural purposes.

Aloun Farms, the current occupant of the Site and an adjacent property to the north, is currently cultivating produce onsite (Photo 3 and Photo 4). The land consists of cultivated and fallow plots, which are accessed by dirt roads that traverse the project Site. An asphalt access road, Mango Tree Road, under the City and County of Honolulu jurisdiction, runs the length of the southern boundary (Photo 6). Along Mango Tree Road towards the southwest corner of the Site, five storage containers of various capacities were found in brush bordering the road (Photo 7).

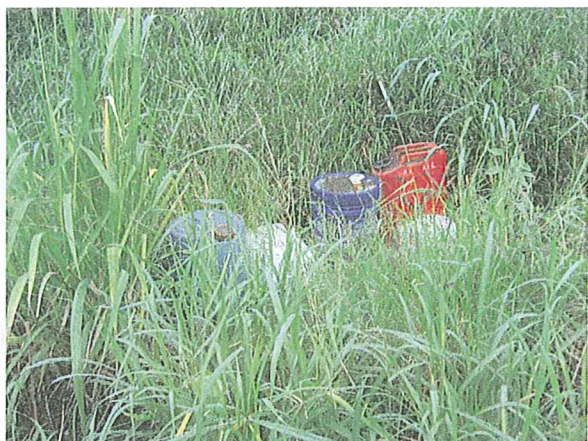
Photo 7: Several storage containers of various capacities.

There were no hazardous chemical containing materials and waste on the Site, except five storage containers of various capacities that were observed in brush bordering Mango Tree Road.

- Storage containers of various capacities were observed in brush along Mango Tree Road towards the southwest corner of the Site. It is unknown if these containers were used to store hazardous chemicals and if hazardous materials may have leaked from these containers. This indicates a material threat of a release of a hazardous substance that could impact the Site.

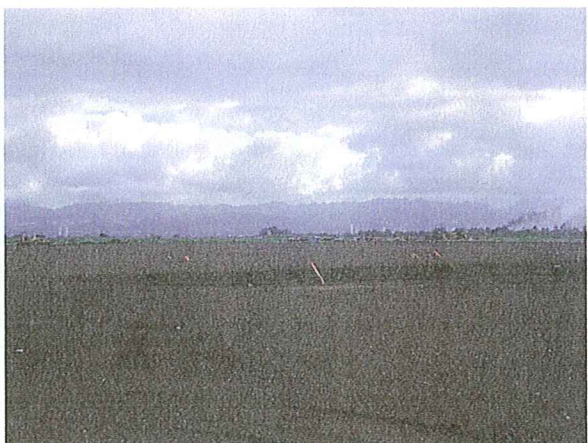
Photo 9: Salvation Army Kroc Community Center foundation.

- On the western property boundary land was being cleared by earthmoving equipment for the foundation of the Salvation Army Kroc Community Center (Photo 9).
- Adjacent to the Kroc Community Center, a bridge was being constructed over a drainage channel with excavators and earthmoving equipment as part of the new North-South Road (Photo 10).
- In the southwest corner of the Site boundary there was a borrow pit with excavators, earthmoving equipment, and soil stockpiles (Photo 11).

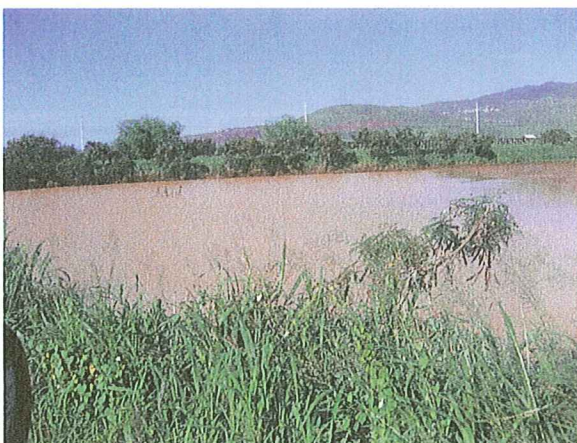
Photo 12: Standing water in an area of lower elevation to the north of the former pesticide mixing facility.

- An area near the O'ahu Sugar Company pesticide mixing and loading facility was observed to have standing water. This area was considered a potential environmental condition, as the presence of the standing water was within 20 feet of the suspected pesticide mixing and loading area and the vegetation within the standing water appeared stressed (AMEC, 2004).

- Standing water was observed in an area of lower elevation to the north of the former pesticide mixing facility and along Mango Tree Road (Photo 12).

Standing water was observed in an area of lower elevation to the north of the former pesticide mixing facility and along Mango Tree Road.
